Provisional Repair of a Zirconia Fixed Partial Denture with Fibre-Reinforced Restorative Composite: A Clinical Report

Although all-ceramic restorations have become popular, they present some biomechanical problems. Some technical failures can be repaired intraorally to help maintain the longevity of the restoration. This clinical report describes an intraoral method for repairing a fractured 4-unit posterior zirconia-based ceramic fixed partial denture using fibre-reinforced composite material.

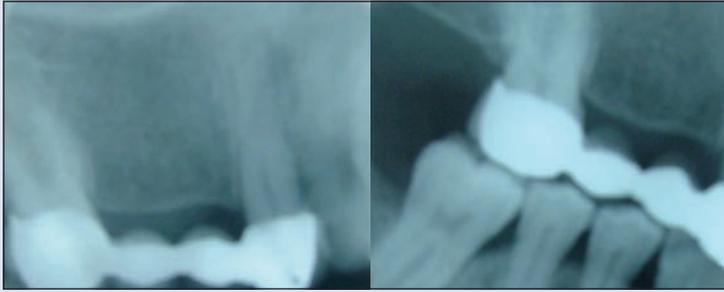
A 46-year-old woman was referred to our clinic with a fractured 4-unit posterior zirconia-based FPD. The retainers were the canine and first maxillary molar. Clinical and radiographic examination revealed the fractured area between the 2 premolar pontics (Fig. 1). The prosthesis had been fabricated only one month earlier. Marginal adaptation, occlusion, periodontal health, colour matching and proximal contacts of the prosthesis were all within normal limits. The patient's only complaint was some roughness in the mouth and she wanted an immediate solution. Because of lack of time, possible trauma to the restored tooth and the difficulty of removing the restoration, an intraoral repair was indicated, even though this type of repair is still experimental. Replacing the FPD was an alternative treatment option if the repair was unsuccessful.

Figure 1: Radiographic view of the fractured bridge.

Fracture of the zirconia FPD reported here occurred between the connector areas of the 2 pontics where high tensile stress occurred during mastication. The failure, therefore, likely occurred because the thickness of the connector between the pontics was inadequate to bear the necessary occlusal load.

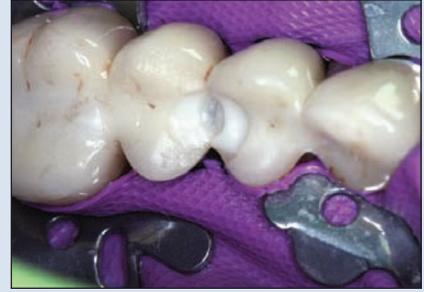
Figure 2: Clinical view of the fractured bridge showing the prepared cavity.

A rubber dam was used to protect the oral mucosa from the adverse effects of etching compound and tribochemical coating. The dam was tied with silk suture material under the pontics of the bridge. The cavity was prepared with a 30- μ m fine-diamond rotary cutting instrument under running water. A small cylindrical cavity (about 1 mm deep) was made within a larger cylindrical cavity (about 2 mm deep) to promote mechanical retention (Fig. 2). To promote satisfactory adhesion, the cavity was acid-etched with 6% hydrofluoric acid gel (Porcelain Bonding Kit, Sultan, Germany) for 5 minutes (Fig. 3), then washed with water, air dried and sandblasted with 30- μ m silicated aluminum oxide (Al₂O₃) particles (CoJet System, 3M ESPE) (Fig. 4). Silane coupling agent (ESPE-Sil, 3M ESPE) was then applied to the surface of the cavity and allowed to air dry for 5 minutes. Bonding agent (Single Bond 2, 3M ESPE) was applied to promote chemical retention.

When repairing an FPD, optimum adhesion between the repair materials and the prosthesis surfaces must be achieved.³⁰ In our case, mechanical retention was promoted by drilling a small cylindrical cavity within a larger cylindrical cavity. A 30- μ m medium diamond rotary cutting instrument was used for preparation under

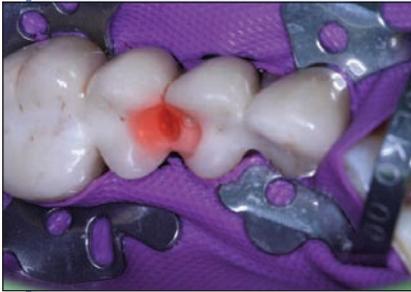
Figure 3: Acid etching material coating the cavity.

It has been reported that roughening the surface of exposed metal or ceramics, using a combination of sandblasting and hydrofluoric acid gives the best results.²⁵ High-alumina or zirconia ceramics cannot be roughened by etching as these materials do not contain a silicon dioxide (silica) phase.²³ Ozcan and Vallittu²³ reported that, while acid etching demonstrated better results for glass ceramics, it did not improve the bond strength of the luting cement to high-alumina ceramics or zirconium oxide ceramic. In practice, etching might only be useful for removing smears from the ceramic.³²

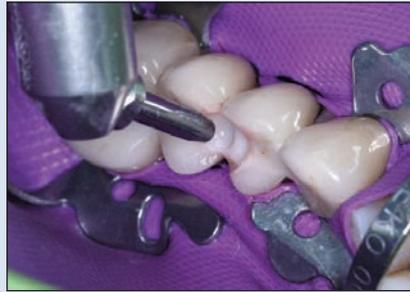
Figure 4: Application of the tribochemical coating.

SiO_x particles instead of Al_2O_3 , together with silane application.³³ A previous study evaluating surface conditioning methods found that silica coating with silanization increases bond strength significantly for all high-strength ceramics compared with airborne particle abrasion with 110- μ m Al_2O_3 and silanization.³⁴

Tribochemical silica coating followed by silanization increases the silica content of the ceramic surface, evidently enhancing the bond between the ceramic surfaces and the luting agent. Because the silica layer is well attached to the ceramic surface, silanes enhance the resin bond.²³ Shen and others³⁵ also reported that the use of silane in conjunction with resin-based bonding agents on ceramic has resulted in a significant increase in bond strength and promotes mechanical retention.

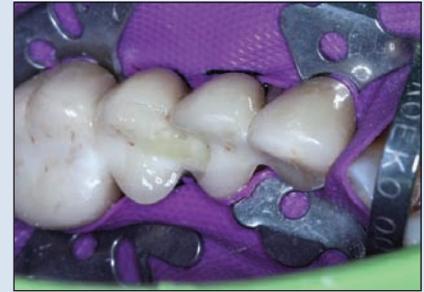
Figure 5: Placement of the glass-fibre bundle.

After surface treatment of the cavity, dual-adhesive resin cement (Rely X ARC, 3M ESPE) was applied to the fractured area. The length of the cavity was determined using a piece of dental floss, then a piece of unidirectional

resin-impregnated 1.2-mm diameter glass-fibre bundle (EverStickC&B, StickTech, Turku, Finland) was cut to this length (Fig. 5). The fibre bundle was prepared for bonding by first wetting the bonding surface with a bonding agent (Stick Resin, StickTech). The bundle was pressed into the cavity with a hand instrument to ensure good contact between the cavity and the fibres. The fibres were then light polymerized for 20 seconds (Fig. 6) and covered with packable posterior composite restorative material (SureFil, Dentsply, De Trey, Konstanz, Germany). The whole area was light polymerized for 40 seconds (Fig. 7). Occlusal contact points were adjusted with a fine diamond rotary cutting instrument (no. 8835KR; Komet Medical, Gebr. Brasseler, Germany) under running water and polished with composite polishing disks (Sof-Lex, 3M Dental Products, St. Paul, Minn.) (Fig. 8).

the bonding strength of the resin-based material which was applied to the cavity. Because of its fluid nature, the dual-adhesive resin cement flowed through the fracture area, filling the space between the fractured pieces. Mechanical support for the repair was achieved by using unidirectional glass-fibre material. The strength of the repair depends on the quantity of glass fibre, the direction of the fibres and their attachment to the ceramic.

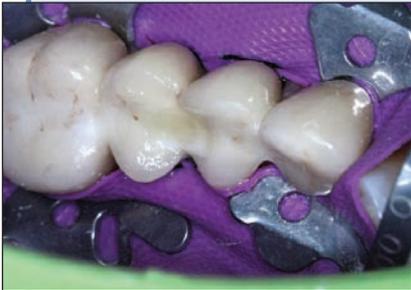
Figure 6: Light polymerized glass-fibre-reinforced composite.

Repaired restorations should be resistant to fatigue. In our case, adding fibre-reinforced composites under the composite resin increased fatigue resistance of the repair.³⁶ In addition, the upper part of the cavity was filled with fibre-reinforced composite and a posterior composite material to ensure wear resistance.

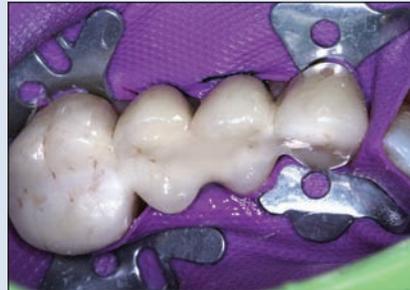
Figure 7: Composite application.

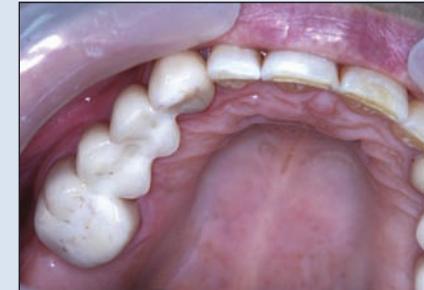
Figure 8: Final view of the restoration.

Clinical evaluations were performed every 3 months to evaluate the repaired restoration in terms of function, fractures and esthetics. After 12 months of follow up, no clinical complications were observed.
